the **Parker** company

SUBJECT: Hooker Chemicals and Plastics, Morenci
RCRA AND ACT 64 VIOLATIONS

Staff Report

Occidental Chemical Corporation
Parker Surface Treatment Products Division
322 Main Street
Morenci, Michigan

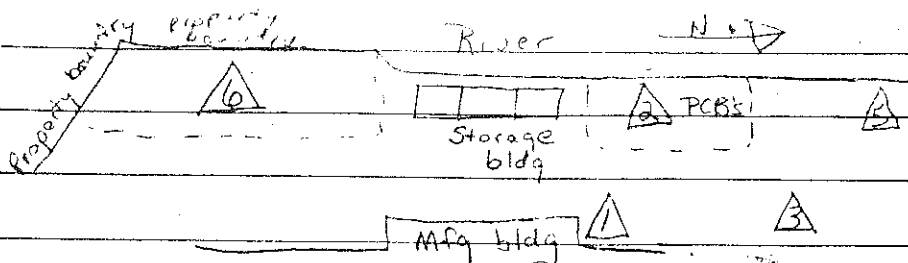
Roy Schrameck, W.Q.D. #1, and I inspected storage area 6 which is south of the storage building next to the river.

There was no easy path to get back to the fence next to the river in storage area 6. First we tried the south and of storage area 6 but drums and lab. samples haphazardly strewn made it impossible to get to the west side of this storage area via this path. Finally, we got through by going along the south side of the storage building and pushing in the fence to get to the west side of storage area 6 which is on a concrete pad.

Mr. Fredricks and Lee Huffaker accompanied Roy and me while we collected 4 samples from the ground-no drums were sampled. The drums which we were most concerned about were two badly decomposed plastic lined fibpac barrels laying on their sides. One of which was leaking on to the ground and had eaten into the wood that the barrel was placed on. The liquid was possibly a chromic acid-like substance, since there was a greenish-yellow material near these two barrels on the ground. Roy sampled this before mentioned material; but, since it had apparently rained heavily the night before the sample was probably more diluted than it would have been if we had collected before the rain. There was evidence of rain because the area was still wet, as it had just rained.

When I had originally seen this contaminated part of area 6 on 6-15-82, there had been a lot more multi-colored liquid on the ground. This likely had been washed away by the recent rain. There was evidence that water washed directly from this storage pad into the river, because there were obvious drainage areas. Some of which were stained dark-not unlike an oil slick.

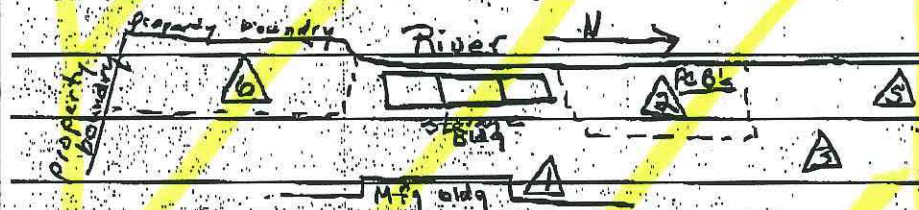
I had received a telephone call (06-08-82) and an aerial photo (June 9, 1982) from Lyle Rowell of Environmental Enforcement Division (E.E.D.) informing me that there were some more drums that neither Lyle nor I had previously known about. Therefore, I asked Mr. Fredricks about storage area 6 which is located on the river on the south side of the storage building.

Mr. Fredricks insisted that there was not any hazardous waste stored there only nonhazardous baghouse dust (phosphates) and empty drums.

I insisted that I needed to take a look. Mr. Fredricks continued to want to know why I thought there was anything back there that may be a problem. Finally, I told him that I had seen an aerial photo that had been taken recently and wanted to check out the area. Then Mr. Fredricks said it was all right and I climbed (squeezed) through several rows of drums to discover a mess. There were approximately 100 drums of which many were corroded, leaking or open. Several drums were open and filled with laboratory bottles filled with samples. Two fiberpac barrels with a....

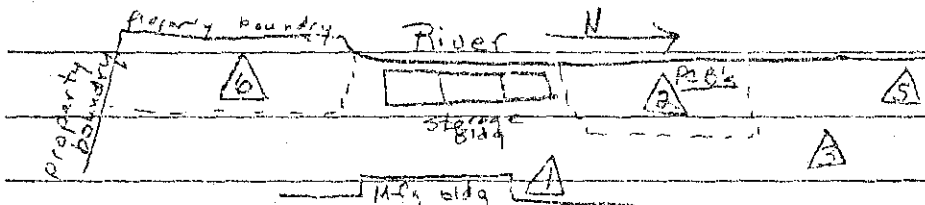
I had received a telephone call (06-08-82) and an aerial photo (June 9, 1982) from Lyle Rovell of Environmental Enforcement Division (E.E.D.) informing me that there were some more drums that neither Lyle nor I had previously known about. Therefore, I asked Mr. Fredricks about storage area 6 which is located on the river on the south side of the storage building.

Mr. Fredricks insisted that there was not any hazardous waste stored there—only nonhazardous baghouse dust (phosphates) and empty drums.

I insisted that I needed to take a look. Mr. Fredricks continued to want to know why I thought there was anything back there that may be a problem. Finally, I told him that I had seen an aerial photo that had been taken recently and wanted to check out the area. Then Mr. Fredricks said it was all right and I climbed (squeezed) through several rows of drums to discover a manhole near. There were approximately 100 drums of which many were corroded, leaking or open. Several drums were open and filled with laboratory bottles filled with samples. Two fiberpar barrels with a...

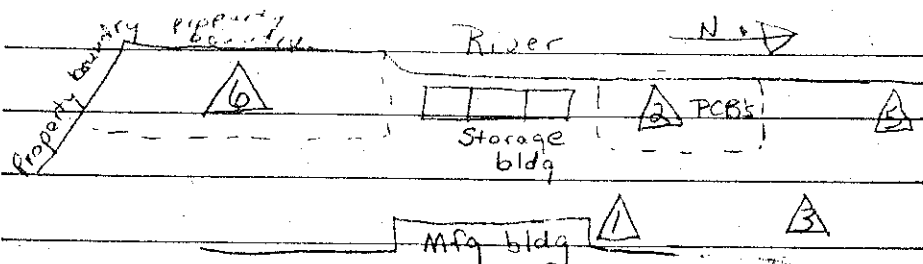
Roy Schrameck, W.Q.D. #1, and I inspected storage area 6 which is south of the storage building next to the river.

There was no easy path to get back to the fence next to the river in storage area 6. First we tried the south end of storage area 6 but drums and lab. samples haphazardly strewn made it impossible to get to the west side of this storage area via this path. Finally, we got through by going along the south side of the storage building and pushing in the fence to get to the west side of storage area 6 which is on a concrete pad.

Mr. Fredricks and Lee Huffaker accompanied Roy and me while we collected 4 samples from the ground-no drums were sampled. The drums which we were most concerned about were two badly decomposed plastic lined fibpac barrels laying on their sides. One of which was leaking on to the ground and had eaten into the wood that the barrel was placed on. The liquid was possibly a chromic acid-like substance, since there was a greenish-yellow material near these two barrels on the ground. Roy sampled this before mentioned material; but, since it had apparently rained heavily the night before the sample was probably more diluted than it would have been if we had collected before the rain. There was evidence of rain because the area was still wet, as it had just rained.
